CASE STUDY

Bearing Isolator | Gearbox

CUSTOM ENGINEERING AND COMMITMENT TO CUSTOMER SEAL THE DEAL AT ARIZONA COPPER MILL

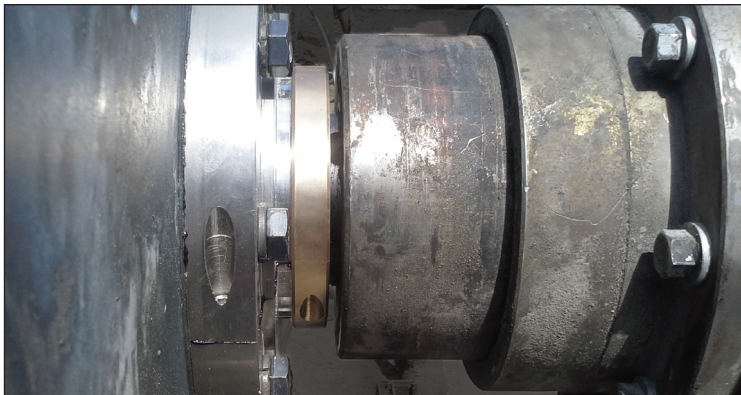
A split custom engineered Inpro/Seal Bearing Isolator provides permanent bearing protection on a Sag Mill Gearbox at a copper mine in the Southwest United States.

Gillespie explained that high oil levels and oil splash make gearboxes notoriously difficult to seal, especially in industrial rotating applications. Inpro/Seal's sealing solution for the gearbox is based on the patented VBXX-D Bearing Isolator. This is a non-contacting, compound labyrinth seal that consists of a stator and a rotor. The stator has a large D Groove that captures oil attempting to flow down the shaft out of the housing. Through a drain port, the captured oil is channeled back to the gearbox oil sump. The rotor prevents outside contaminants from entering the gearbox by collecting them in the labyrinth design. Centrifugal force then expels the captured contaminants to the outside environment. The result is a permanent, non-contacting seal that efficiently keeps the lubricant in the gearbox. It also prevents outside

Inpro/Seal modified a standard VBXX-D Bearing Isolator to fit the gearboxes unique challenges. This custom engineered design included:

- Being split to allow seal installation without decoupling equipment
- A larger D Groove to capture the volume of oil flowing through the system
- An external drain and revamped system to return oil to the sump

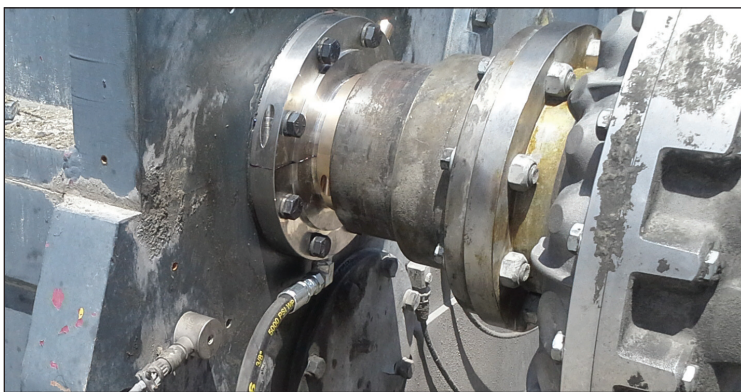
An external drain was designed to accommodate the operational flood in the Sag Mill Gearbox bearing housing.

An operational flood in the bearing housing compounded the sealing challenge for the SAG mill gearbox. Unlike most gearboxes that splash oil into the bearings, the gearbox on the SAG mill pumped oil into the center of the double row spherical roller bearings. This ensured continuous lubrication to the bearings, but also tended to throw the oil toward the lip seal. Oil that was attempting to flow back through the bearings to return to the sump was impeded, creating an operational flood. This placed additional pressure on the lip seal and increased their failure rate. A permanent solution needed to be able to perform in an operational flood and be installed on-site without decoupling equipment.
