Wind Turbine Generator

Industry: Power Generation – Wind

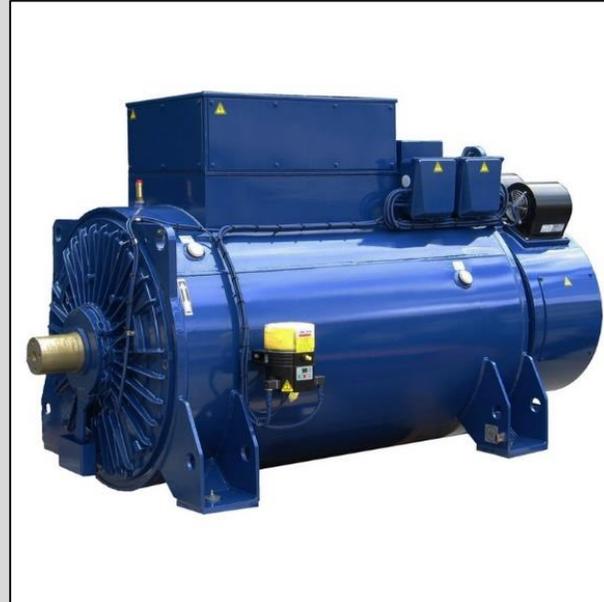
Wind Turbine Generator

A wind turbine generator was suffering from grease leakage as the existing lip seals continually suffered failures. Frictional heat caused the seal to harden, lose flexibility, and leak. Heat transfer to grease caused carbonization, contributing to shortened seal life. Additionally the heat generated from the lip seals was creating power loss, lowering output potential of the turbine.

Customized Inpro/Seal® Bearing Isolators were installed on the generator bearing housings. Inpro/Seal Bearing Isolators are non-contacting compound labyrinth seals that permanently protect against contamination ingress and lubrication loss. The unique design used on this application incorporated an internal rotor to contain grease lubricant within the bearing assembly.

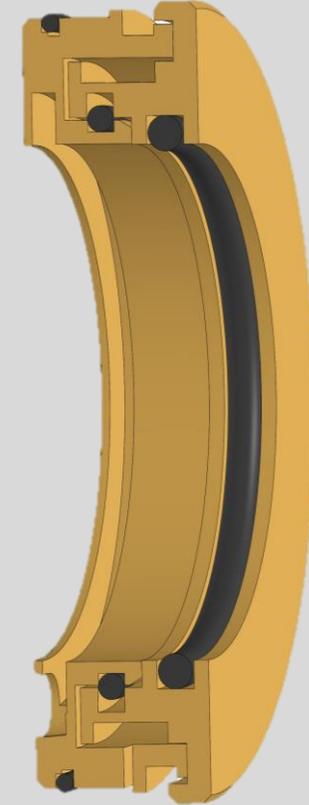
Inpro/Seal Bearing Isolators replace OEM lips seal and can be customized to fit exact equipment dimensions
