Bucket Elevator

Seal Position: **Head shaft**

Industry: **Pulp and Paper**

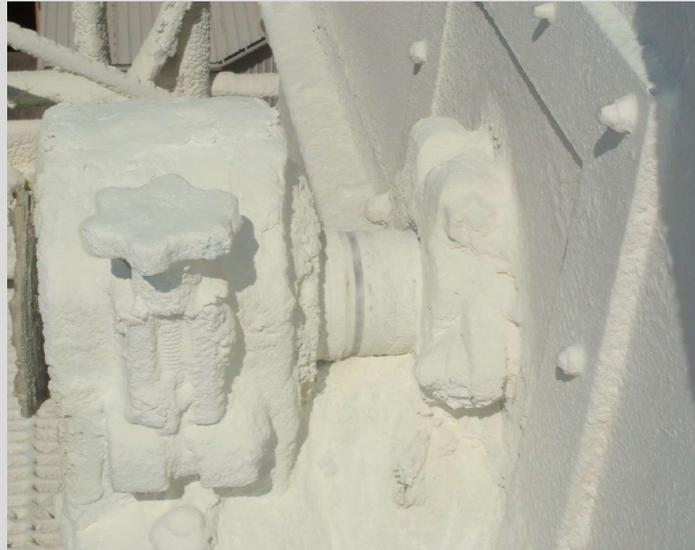
Excessive lime dust leakage from the OEM head shaft seals contaminated the adjacent pillow block bearing and surrounding process area. The OEM sealing method was a braided compression packing. Due to the nature of the product, and the inability to provide any type of flush, the compression packing required constant maintenance and would need to be replaced every three months.

Before: Lime dust leaking onto adjacent pillow block bearing and surrounding area

An Inpro/Seal® Air Mizer® CEMA shaft seal was installed. The Air Mizer CEMA is a non-contacting, non-wearing shaft seal specifically for CEMA designed conveying equipment. It's unique design utilizes a positive air purge to permanently eliminate product leakage.

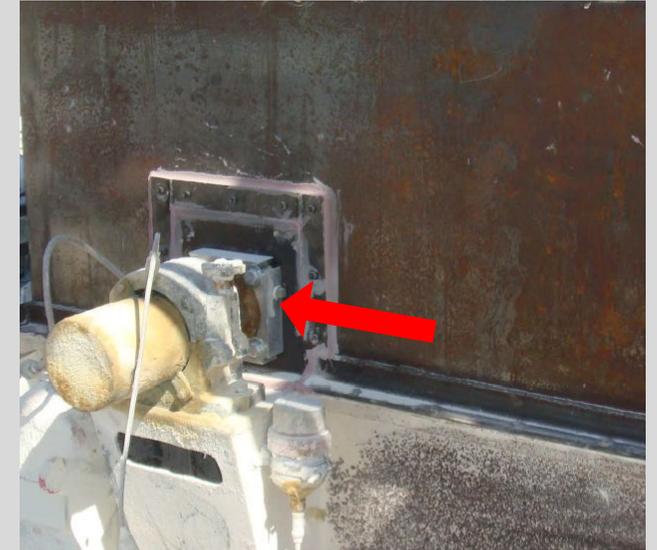
The Air Mizer CEMA shaft seals were installed in 2011 and performance has been outstanding with zero maintenance issues. Replacement seals were ordered in 2020.

After: Inpro/Seal Air Mizer CEMA shaft seal installed
