CASE STUDY

Air Mizer® | Side Entry Agitator

SIX LEAKING AGITATORS FIND A PERMANENT SEALING SOLUTION

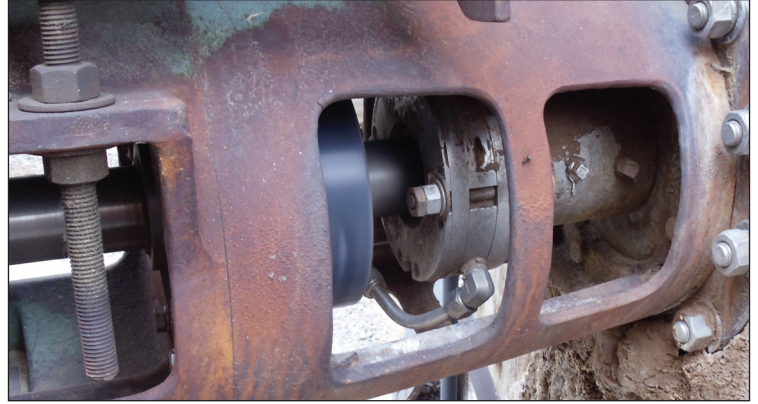
One of two split stainless steel Air Mizer shaft seals installed on white liquor tank agitators.

In December 2005, a split custom engineered stainless steel Air Mizer was installed on one of the white liquor tank agitators. It proved to be the perfect solution for their leaking agitators. Other installations followed in rapid succession – the second white liquor tank agitator in Aug 2006, and the indoor slurry agitators in 2006, 2007 and 2008.

Hintz said “The split designs made installation quick and easy. No modifications to the agitators were required, and there is no on-going maintenance with the seals other than maintaining a low pressure air purge.”

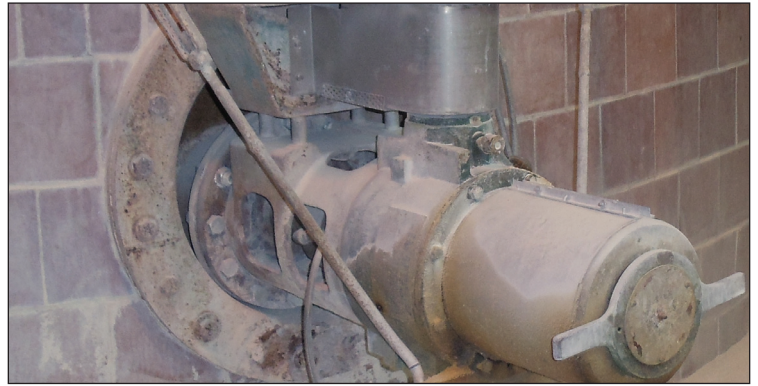
One of four slurry tank agitators installed with Inpro/Seal Air Mizer shaft seals to eliminate product loss and decrease maintenance costs.

The other four agitators were located on tanks inside the mill. These tanks held abrasive ground Calcium Carbonate and Filler Clay slurries. Because the slurries are abrasive, wear to the shafts and packing was excessive. This led to frequent re-packs, unnecessary maintenance and significant product loss to the drain. Flushing the packing with clean water would delay the breakdown, but wasn't acceptable due to dilution of the product in the tanks.
